# Aircraft Accident Investigation

Report 802-1017

Advance Airlines of Australia  
Beech Super King Air 200 VH-AAV  
Sydney (Kingsford Smith) Airport,  
New South Wales  
21 February 1980.

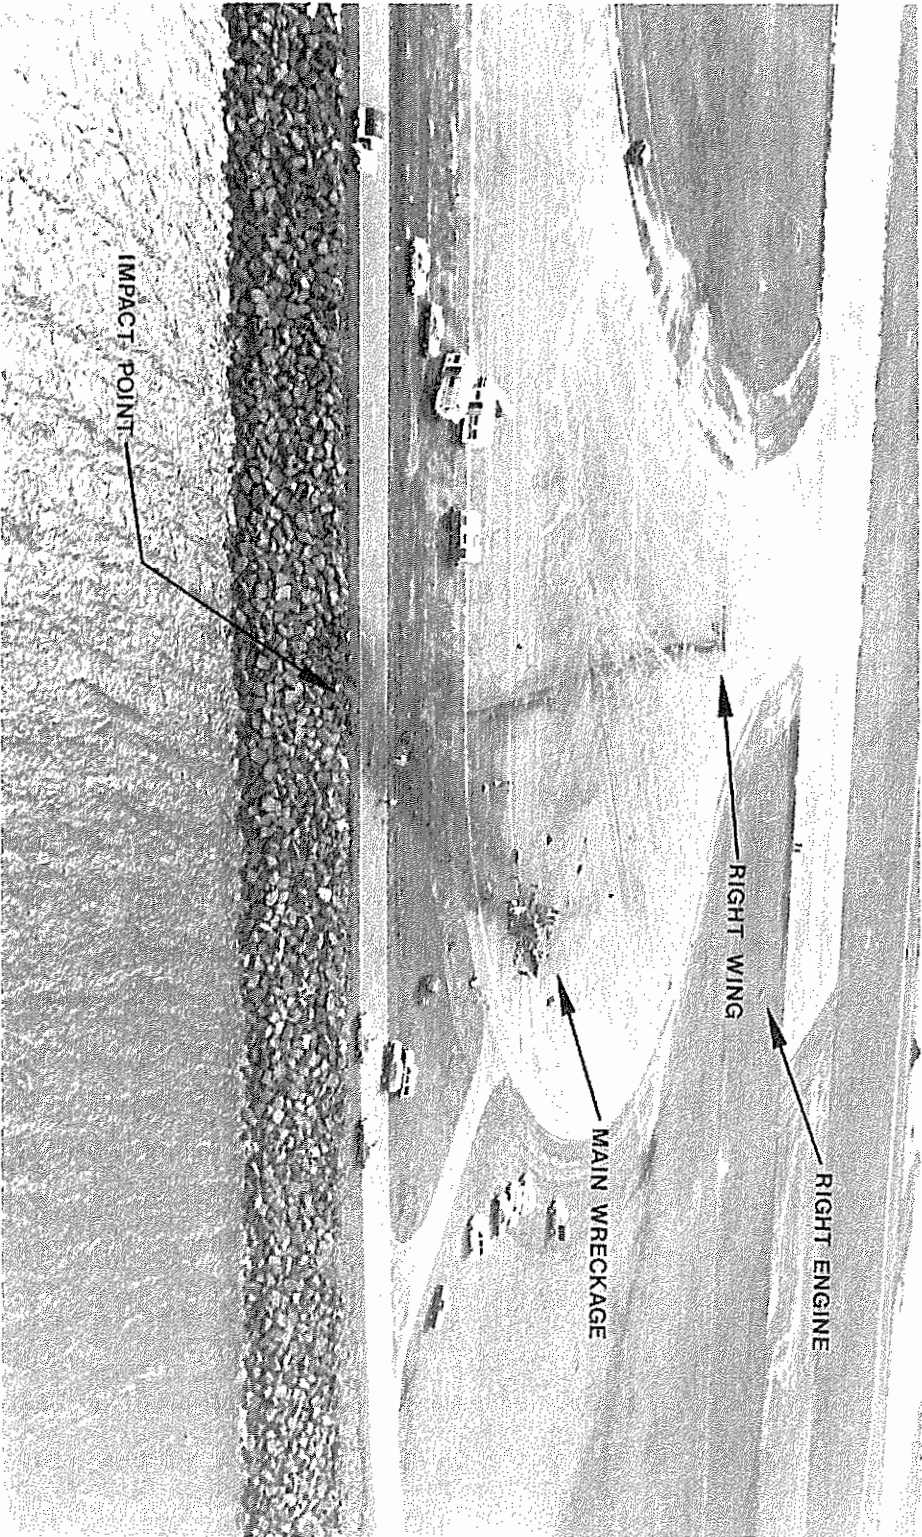
Fig. 2. The accident site

The aircraft struck the sea wall in a nose-high attitude, banked approximately 5 degrees to the left and skidding 19 degrees to the right.

As the lower fuselage was destroyed by fire, it was not possible to establish an accurate pitch attitude at impact. However, the nose section, as far aft as Station 77, had cleared the wall and there was ample evidence that the fuselage had been subjected to high vertical deceleration at impact. Because of the large angle of yaw and nose-high attitude, it is considered likely that the collision with the sea wall was not the first impact. It is probable that the aircraft struck the water first and then ricocheted into the sea wall. Damage to the right propeller supports this hypothesis. There was forward bending of all blades, consistent with contacting a medium such as water.

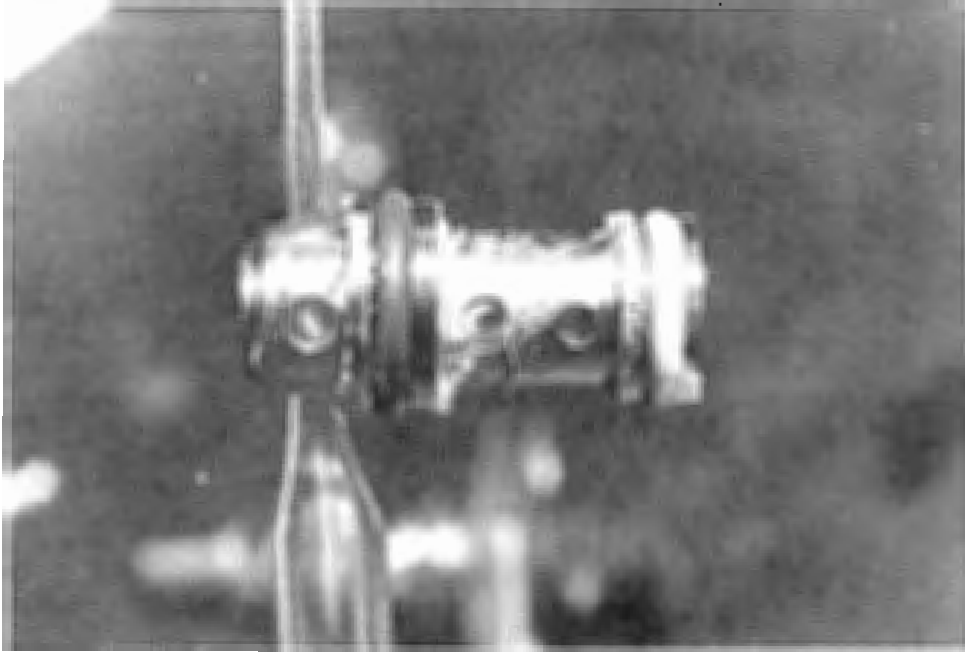
**Fig. 3. Gelatinous deposit on left engine FCU bypass valve sleeve assembly.**

Water was found throughout the various chambers of the FCU and its associated fuel pump. In addition, many of the components, such as valves, were found to be coated with a translucent material, resembling petroleum jelly. On drying, these became white powdery deposits. The deposits varied from thin films to quite thick coatings, and were sometimes associated with rust-like deposits. (Refer Figs. 3 and 4)

As noted in Section 1.16.1, many of the components of the left FCU were coated in a translucent material that, on drying, became a white powder. Electron probe micro analysis of a sample was carried out. The results indicated that the sample contained the elements aluminium, oxygen, chlorine and potassium. The former two were present in considerable quantity whilst chlorine was estimated at 5 to 10 per cent and potassium as a strong trace. No other elements, above the atomic number of carbon, were evident. It was noted that the sample displayed slight volatility and charring under the conditions of the electron beam and vacuum, a situation typically associated with the presence of an organic material.

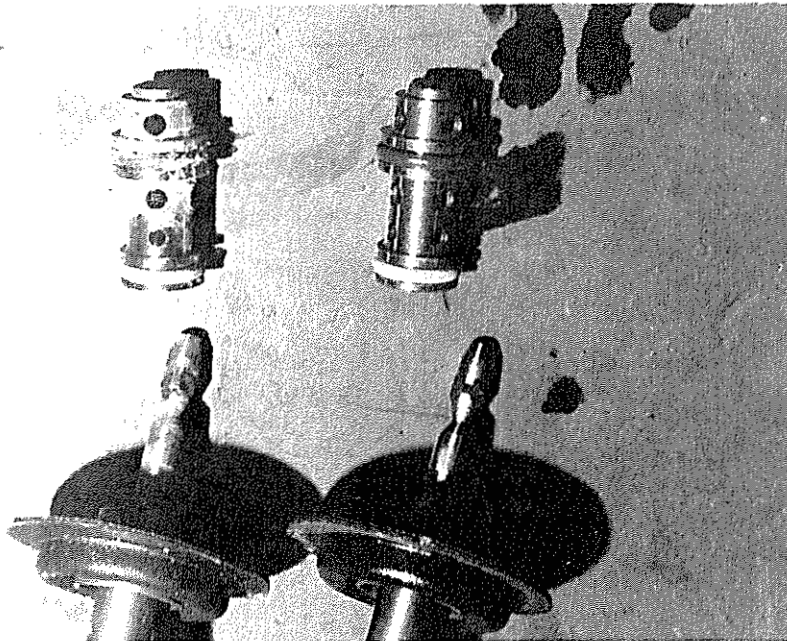
**Fig. 4. Bypass valve and sleeve assemblies of left and right engine FCUs. The left engine components show considerable rusting and deposits. The gelatinous deposit on the left engine sleeve assembly has dried to a white powdery material.**

The left engine fuel control unit (FCU) did not sustain significant impact damage and could have been functionally tested. However, when it was removed from the engine water droplets were noted in the fuel nozzles, transfer tubes, flow divider and FCU outlet line. The unit was disassembled to determine the extent of contamination and samples were collected by syringe for further investigation. (Refer Section 1.16.5)
